Project Summary

Saints John Mine and Mill Complex Saints John Tailings Reclamation Project

Summit County, Colorado

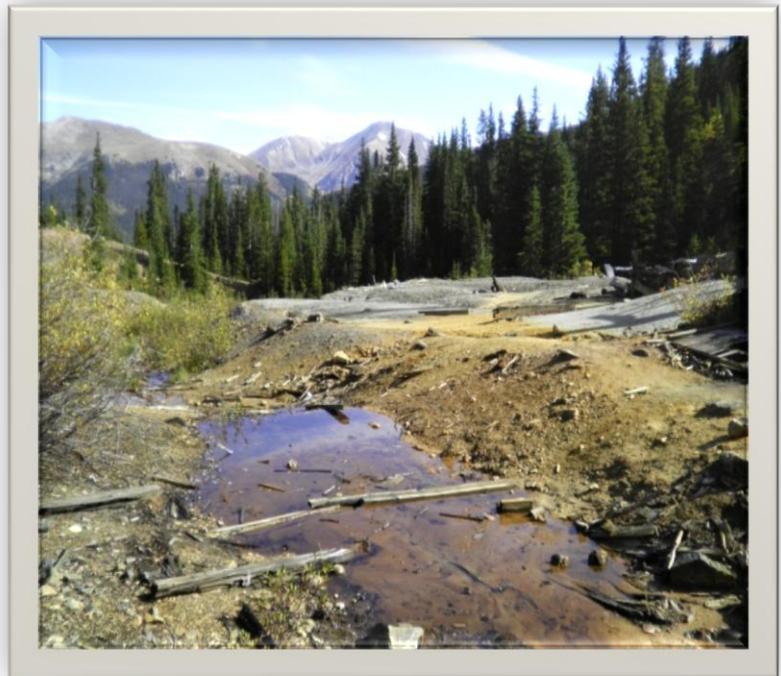
Tailings Prior to Removal

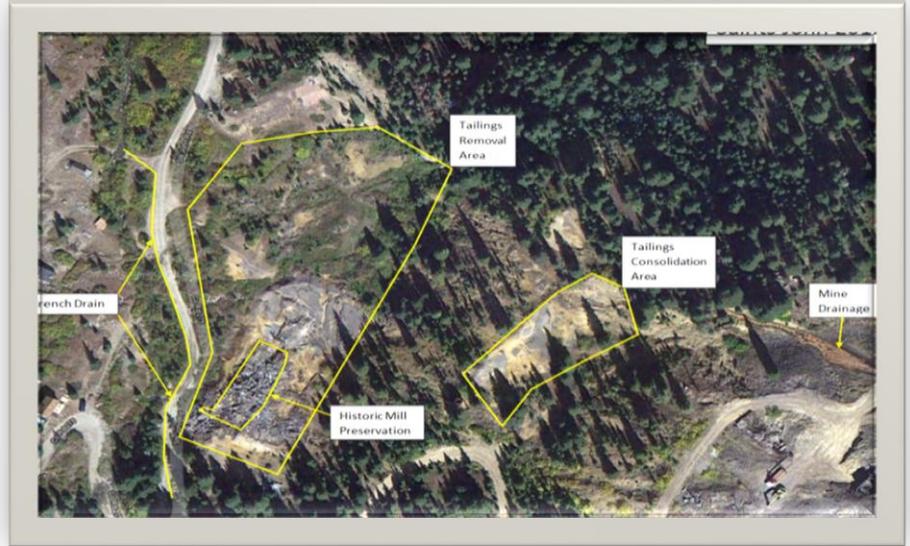
Aerial photo showing French drain, removal and consolidation areas

Contractor mobilization and site preparation began in early September of 2012. A French drain was installed to capture water that was flowing from the stream through the tailings. Actual tailings removal began in mid September. Removal work continued until November when the project was placed on winter hold. Work recommenced in June of 2013 and all tailings removal and earthwork was completed by August of 2013.

The work included excavating over 23,000 cubic yards of tailings from the removal area and placing them in the consolidation area. More than two thirds of the tailings were located USFS lands. Care was taken to preserve the historic mill ruins while excavating the tailings. After the removal was completed the consolidation area was capped with on-site cover material and revegetated. Other disturbed areas outside the wetland boundary were also revegetated.

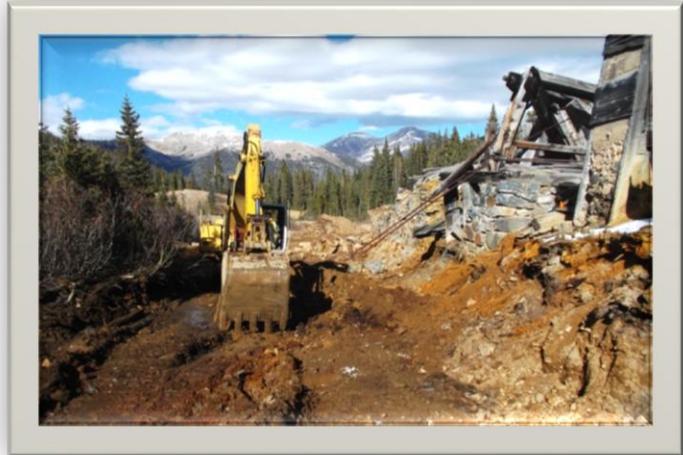
Removing Tailings Around Historic Structure

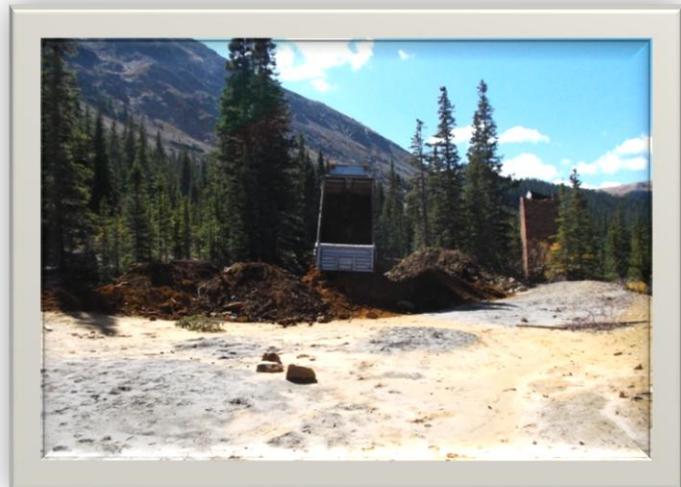
Placement of tailings in consolidation area

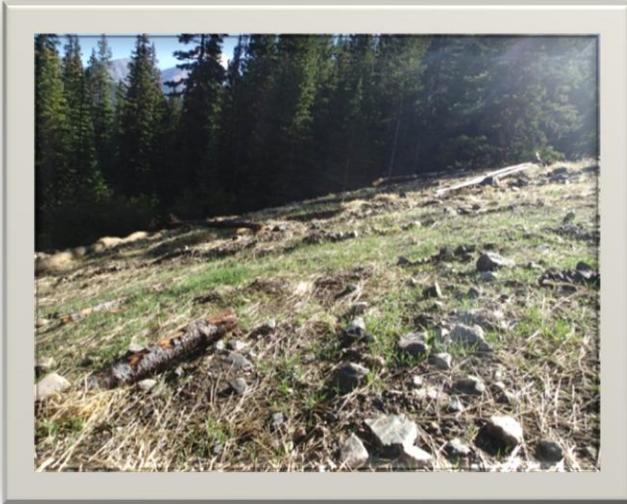
*Reclaimed Tailings
Consolidation Area*

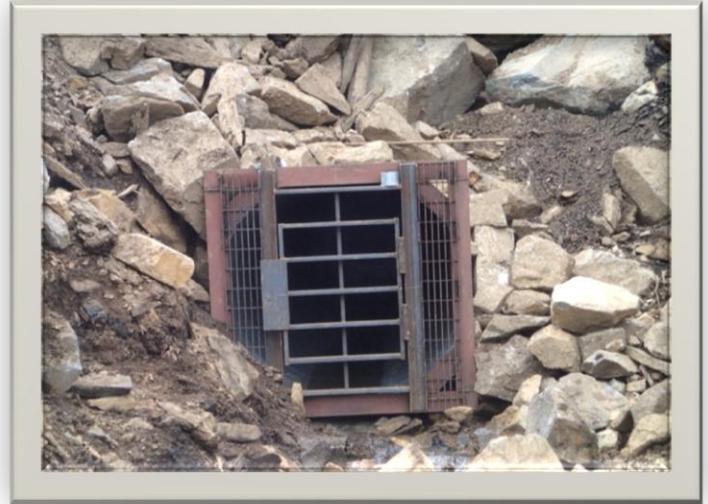
Safeguarded Adit Opening

A 15 foot by 8 foot open adit with a depth of over 100 feet was also safeguarded as part of the project. The adit was cleared of debris and a 30 foot length of 48 inch diameter corrugated steel pipe, with a drainpipe, was placed in the adit. The adit included a bat grate. Also, the ditch alongside Forest Road 275 was restored.

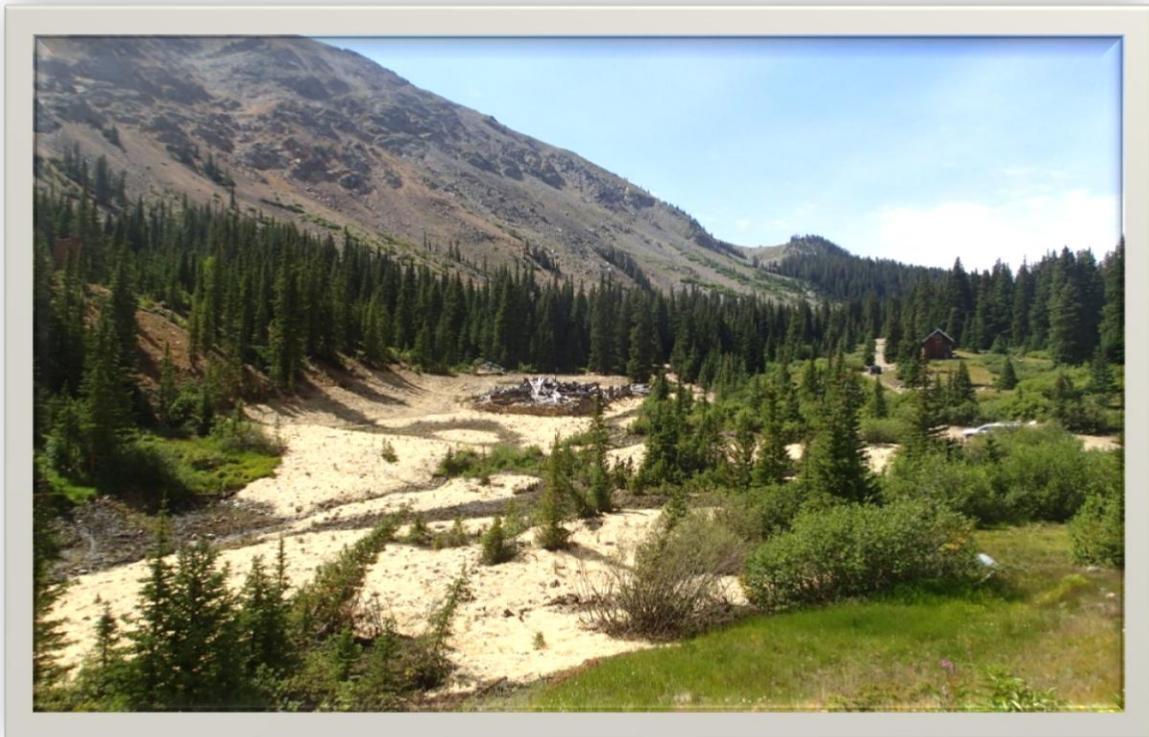
Tailings Removal Area After Revegetation

The wetland restoration work began immediately after construction concluded. The wetland areas were restored by planting over 14,000 container grown native species, 4,800 willow cuttings and 750 trees. A native wetland seed mix was placed on approximately 3 acres in the tailings removal area.
