Swan River

Fishery Survey Report

Jon Ewert, Aquatic Biologist, Colorado Parks and Wildlife
March 2018

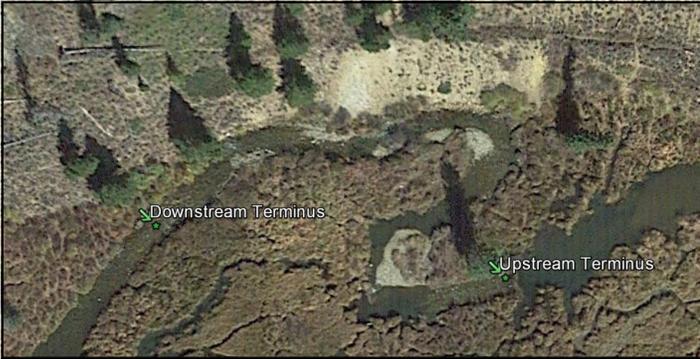
Location of lower survey reach

The lower reach measures 464 feet in length and 15.8 feet in average width. This is a free-flowing section bounded on both ends by beaver pond complexes. The upstream terminus of the reach is a beaver dam.

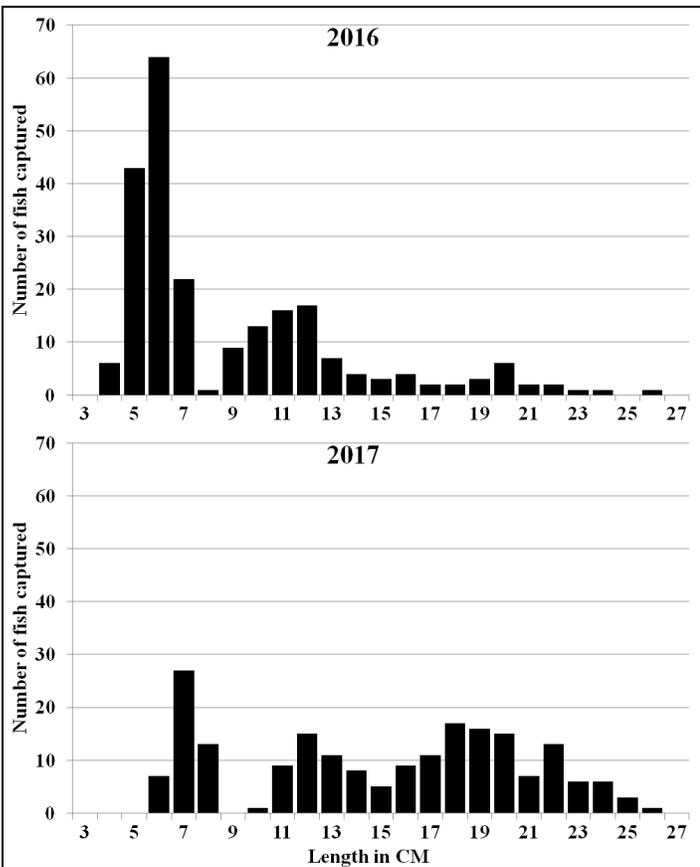
Population estimates for all three surveys are displayed in the table at left. The two estimates derived from the lower reach vary widely. The size distribution of brook trout captured in the lower reach is displayed at left and offers some insight as to why the estimates were so different. In 2016, few adult fish (>15 cm) occupied the reach, while in 2017 adult fish dominated the reach. This is likely a function of the dates of the surveys. Being a fall-spawning fish, adult brook trout probably move upstream out of the nearby beaver ponds in search of spawning habitat. In 2016, the adult fish had probably not made this movement yet, but the 2017 survey took place approximately two weeks later. Based on the condition of the mature females that we handled, it appeared that we visited the site approximately one week prior to the peak of spawn in 2017. In the future, we will place higher priority on conducting the survey on consistent dates in order to produce results that are more comparable.

Size distribution of brook trout captured in lower reach

It is interesting to note that the 2017 survey at the lower site found significantly fewer small fish—both juvenile brook trout (averaging 5-8 cm) and mottled sculpin. Mottled sculpin are a small native fish species and are an important indicator of stream health. This reach contains the highest density of mottled sculpin that we have found to date anywhere upstream of Dillon Reservoir.

There are two possible reasons for the difference in abundance of these two groups of fish. The first and most likely is that territorial behavior of spawning adult fish in 2017 temporarily displaced the smaller fish out of the survey reach. The second is that the disturbance upstream caused by the restoration project had some stressful effect on the downstream fish population. Future surveys will provide more insight to help answer this question. In addition, this area would be a good candidate for water quality monitoring through Colorado's River Watch program, if there is interest among a local volunteer group to do so.

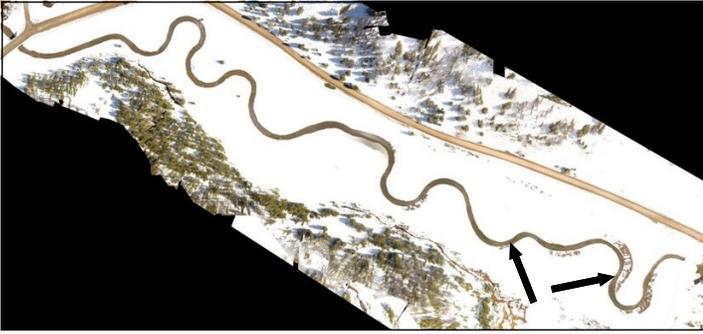
Restoration reach with electrofishing station indicated by arrows. Photo by Jeremy Webber.

The location of the upper reach is displayed at left. The reach that we surveyed is 567 feet in length and averaged 18.9 feet in width. It encompassed multiple newly constructed riffle-pool-run sequences. Population estimates appear on the previous page. Because the restoration project constructed an entirely new channel, all fish occupying this reach had to be migrants from either upstream or downstream. No fish have been stocked. The three sculpin that we captured probably migrated from downstream because the species is not known to occur upstream of this point in the Swan River drainage.

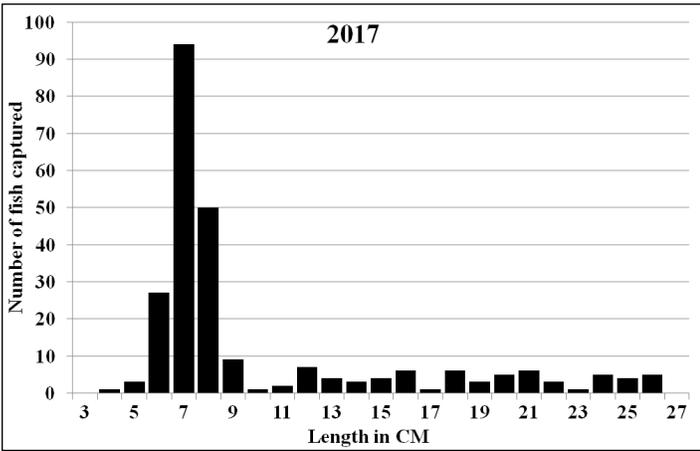
Size distribution of brook trout captured in the upper reach

The size distribution of brook trout captured in the upper reach is displayed at left. We captured a wide size range of adult fish up to 268 mm (10.6") in length. The very prolific juvenile population most likely drifted in from upstream locations during the 2017 runoff season, which is a common dispersion route for young trout. It is unlikely that adult brook trout successfully spawned here in fall 2016 because in-channel construction concluded in early November, and the stream channel was connected at this time — approximately a month later than we estimate the peak of brook trout spawning activity. Regardless, the fish occupying the reach represent the auspicious beginnings of a good recreational brook trout fishery.
